**CLEAN WATER ACT COMPLIANCE INSPECTION
U.S. ENVIRONMENTAL PROTECTION AGENCY, REGION 5**

Legend Farms Dairy, LLC

Date of Inspection: April 20, 2017 - April 21, 2017

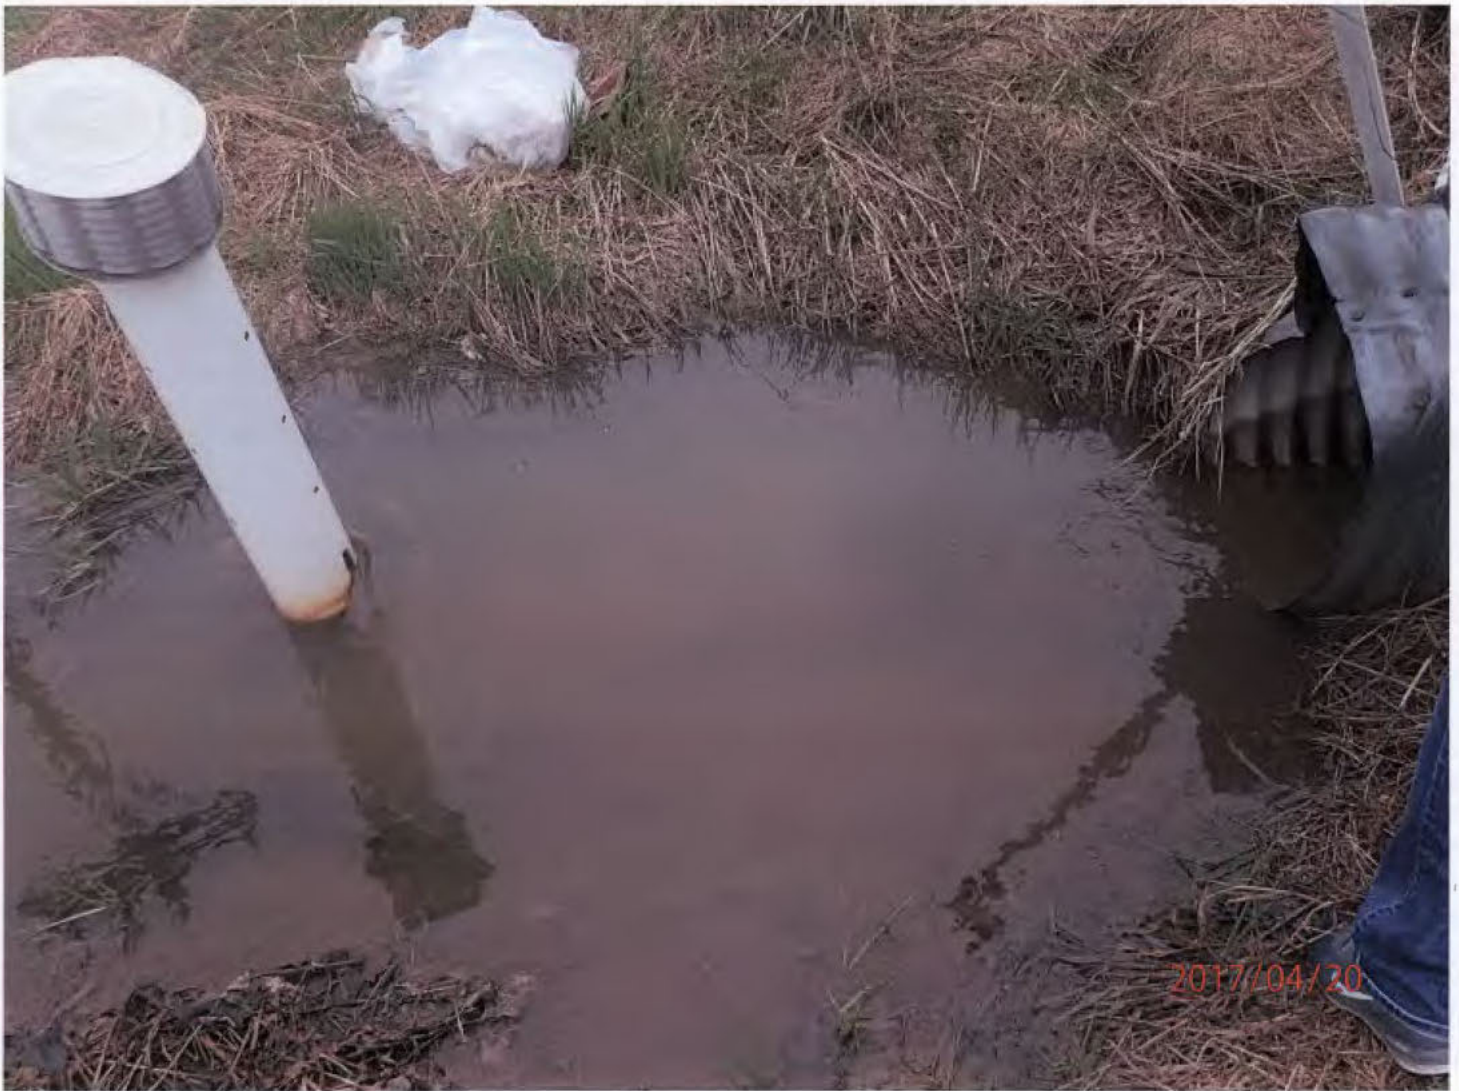
Photo Number: P4200030

Description: Tile riser located on south side of County Road F.

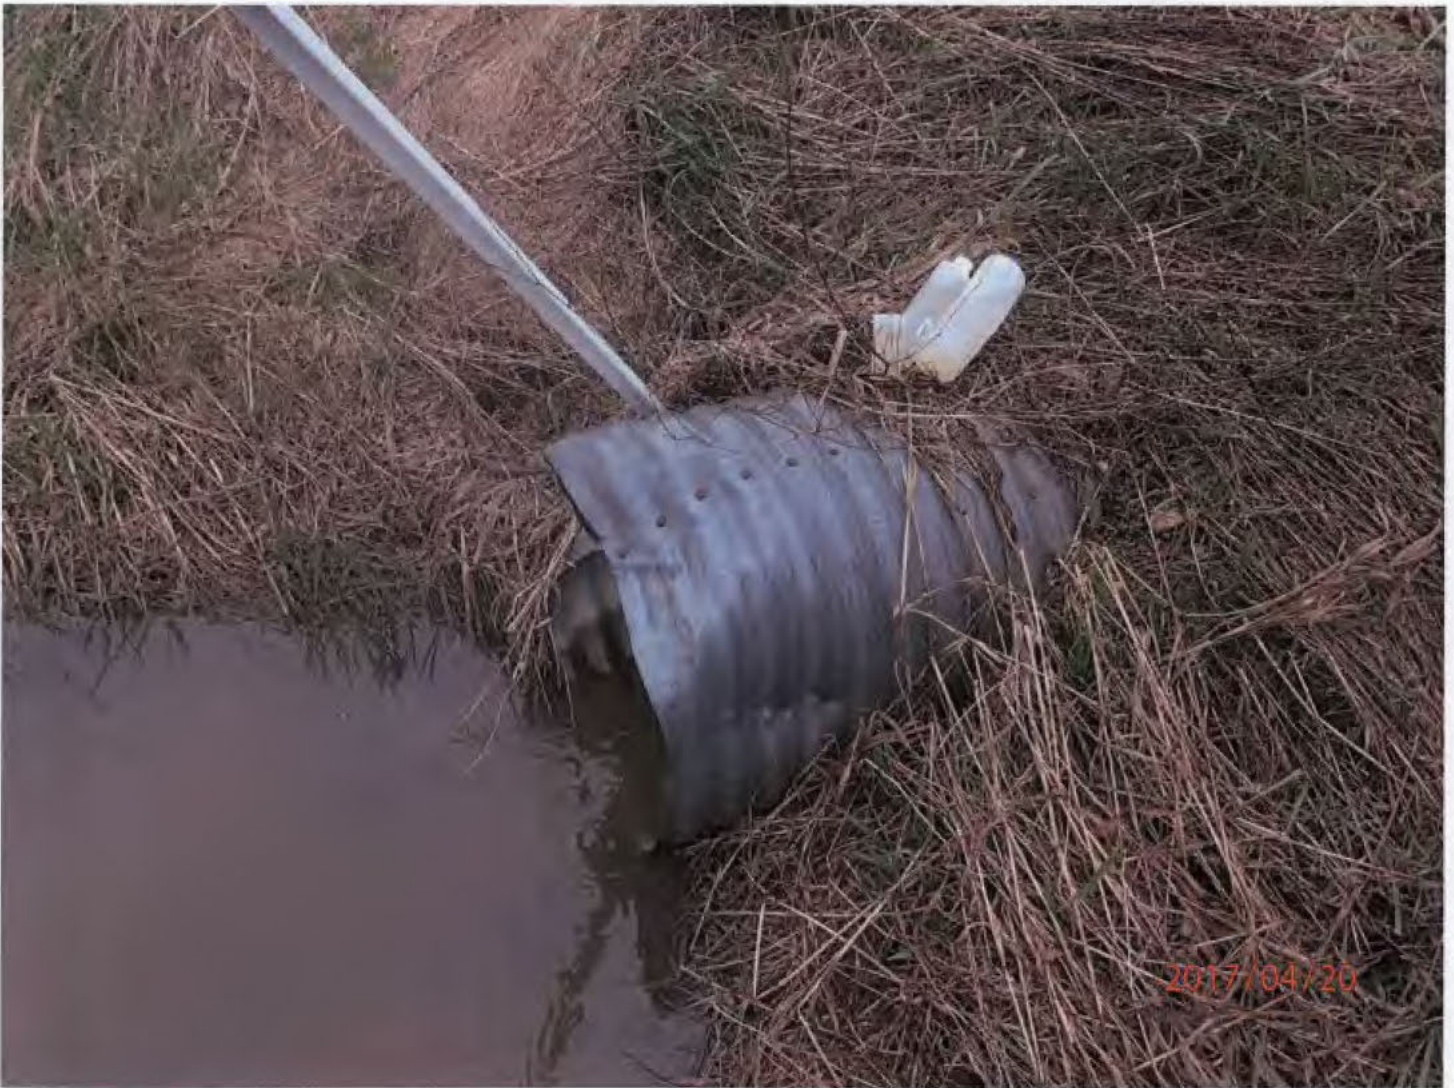
Photo Number: P4200031

Description: Sample S01 collected at the culvert outlet on the south side of County Road F.

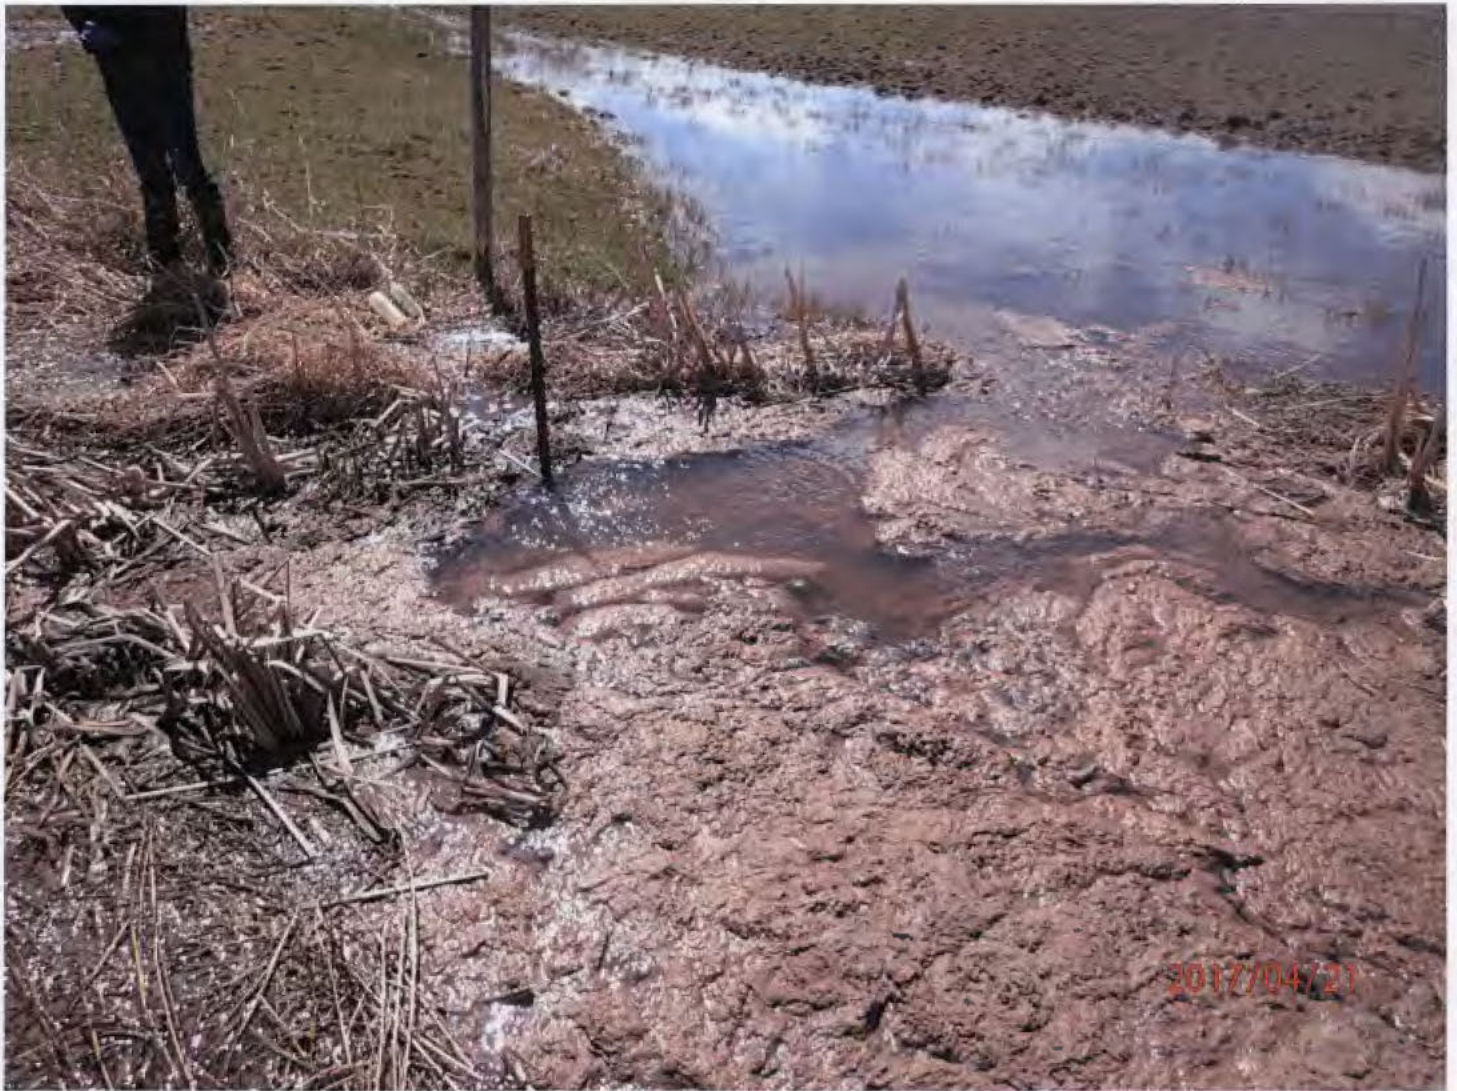
Photo: P421000064

Description: WDNR met EPA on County Road F and showed EPA that near the rebar in the photo was where the tile inlet located west of 2nd driveway west of Lilac Lane on the north side of County Road F outlets into the roadside ditch along the south side of County Road F. Flow is coming up from the tile outlet and flow is also coming in from the southeast and east from a swale.

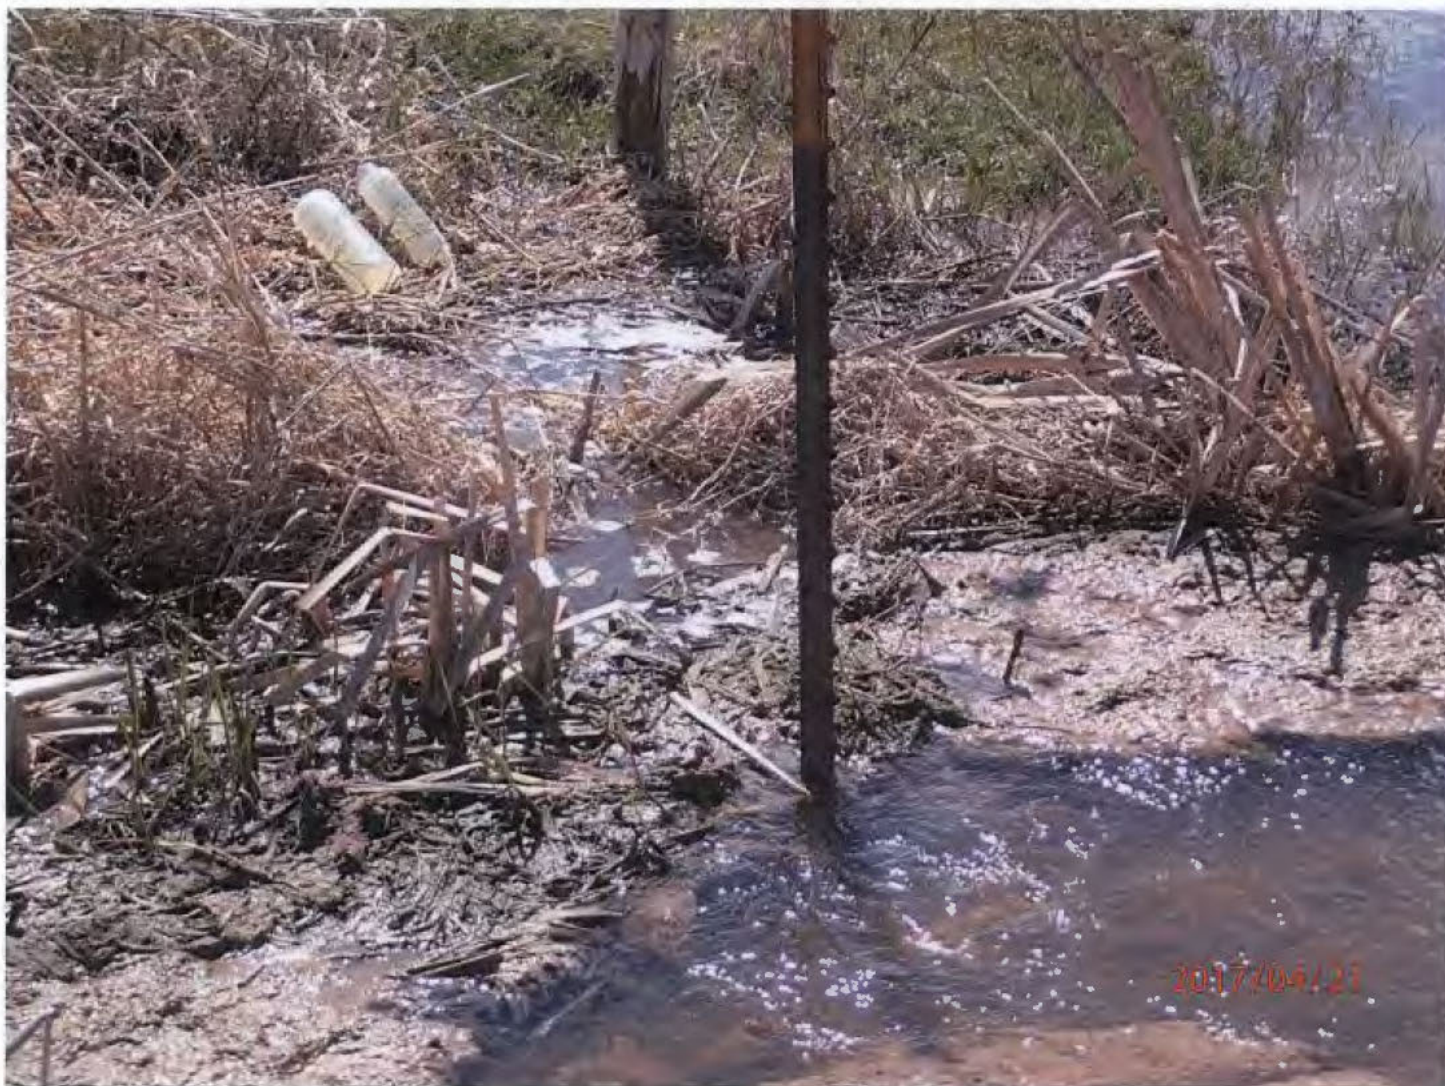
Photo: P4210065

Description: Sample S01-A - Collected near the rebar in the photo.

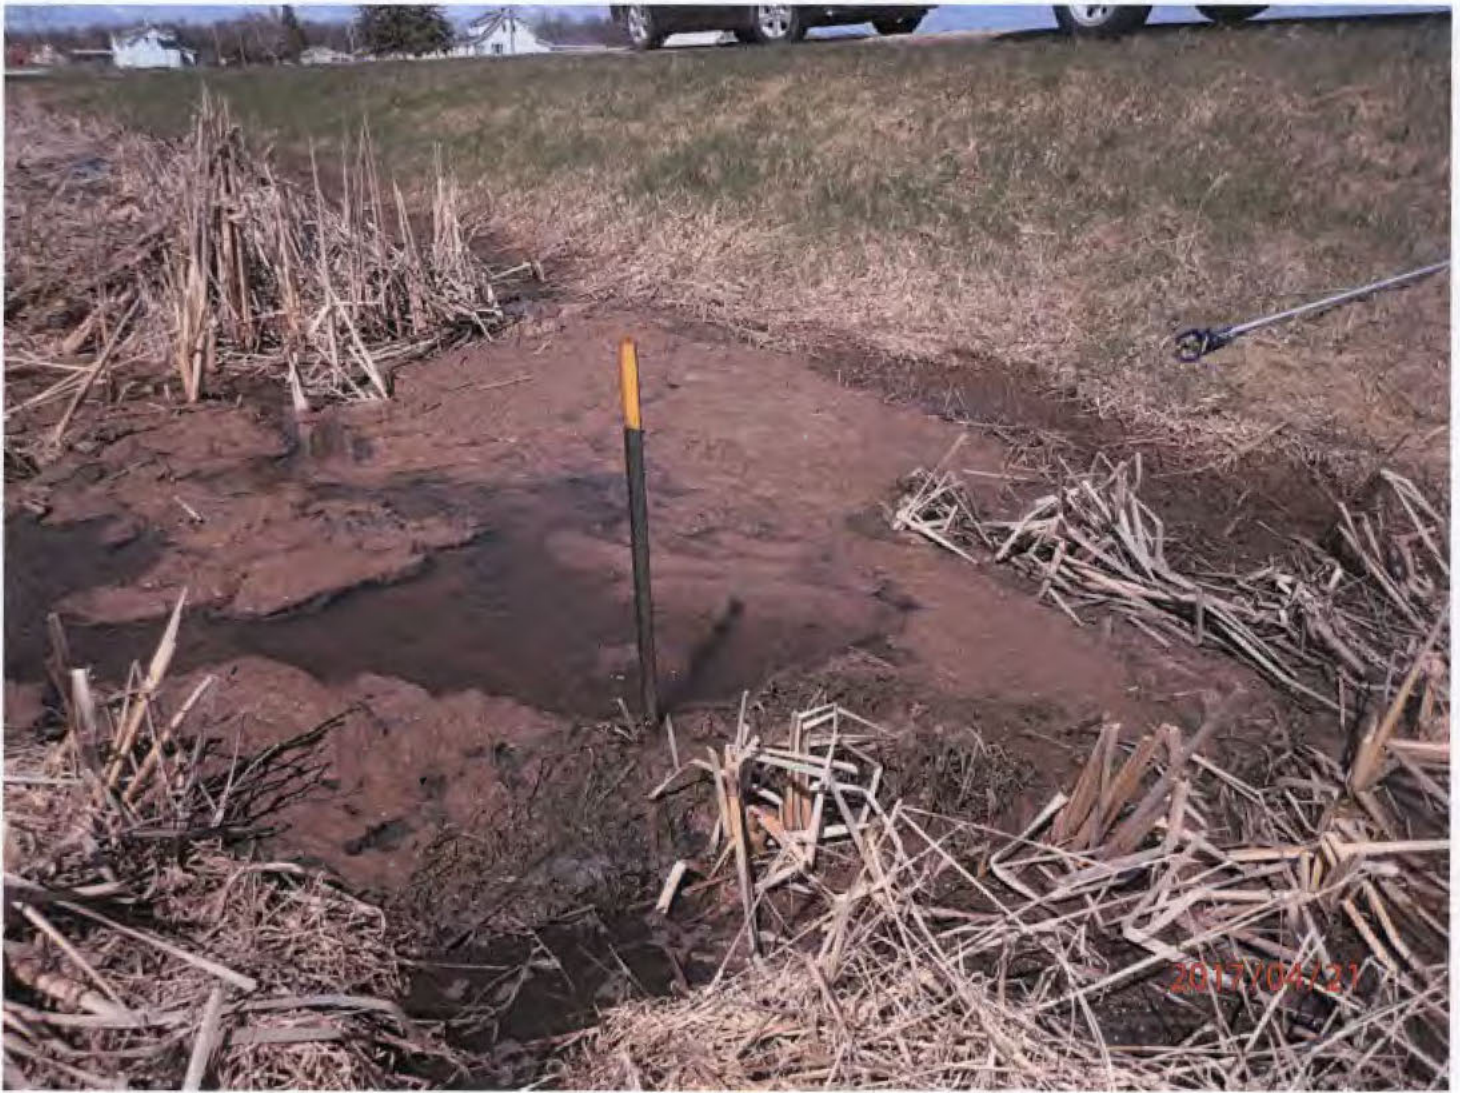
Photo: P4210068

Description: Sample S01-A was collected near rebar post.

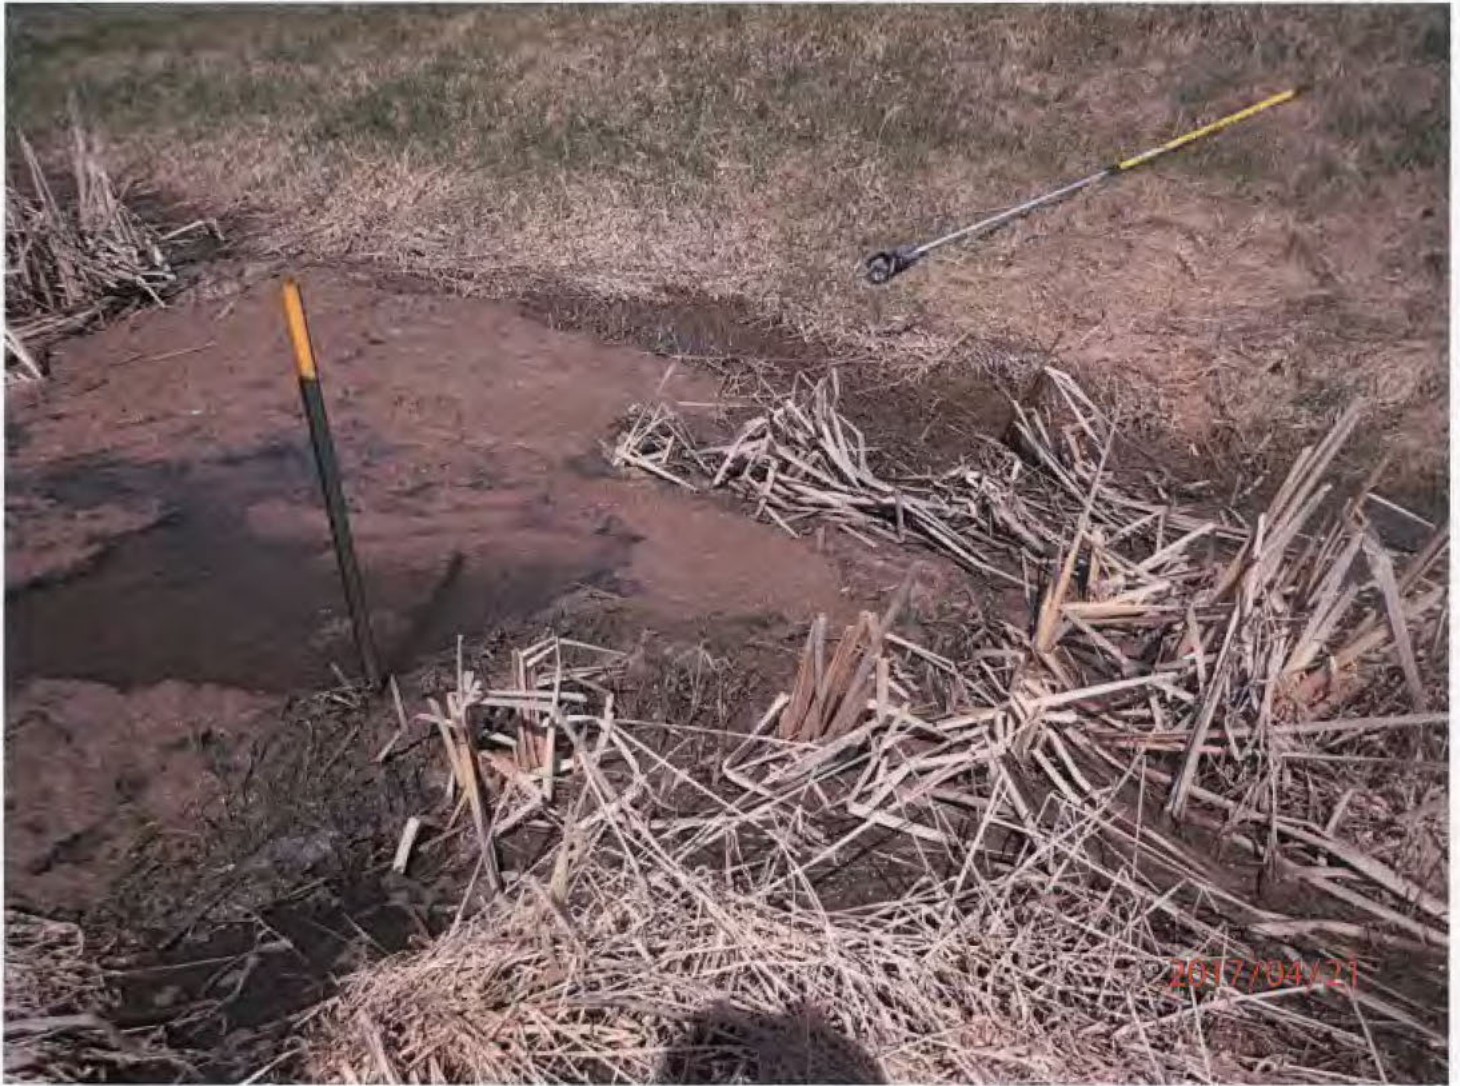
Photo: P4210069

Description: Sample S01-A was collected near rebar.

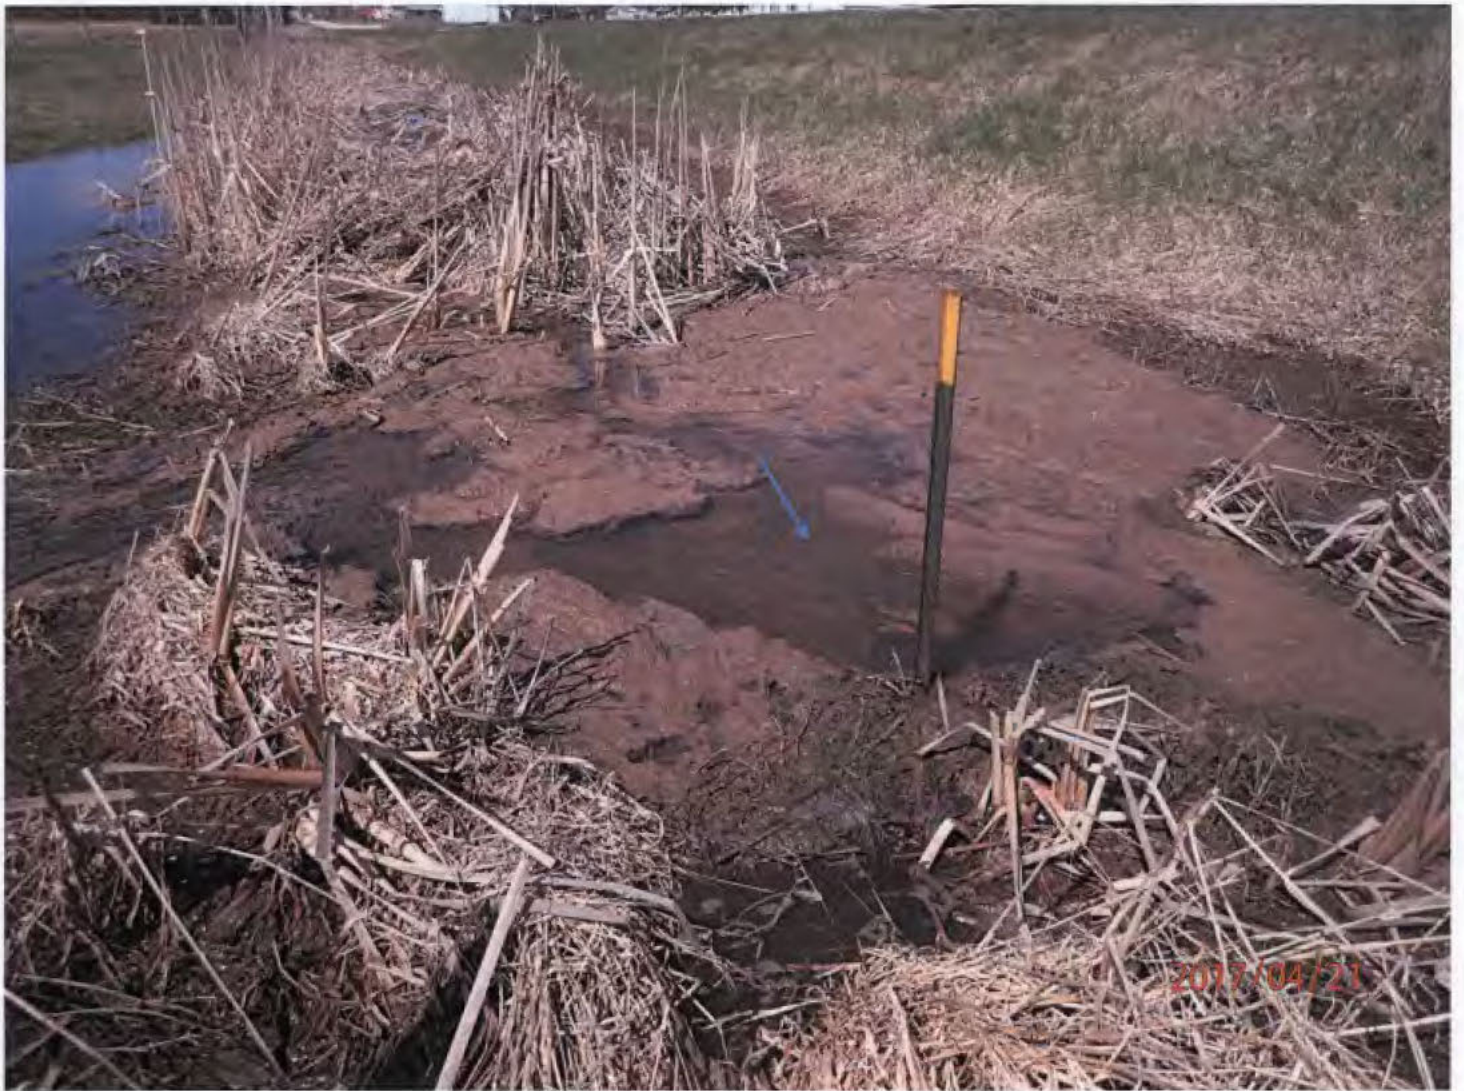
Photo: P4210070

Description: Photograph was taken to show the ripples near the rebar in the water which was identified by WDNR as the location where the tile outlet was located. Blue arrow is pointing to ripples in the water.

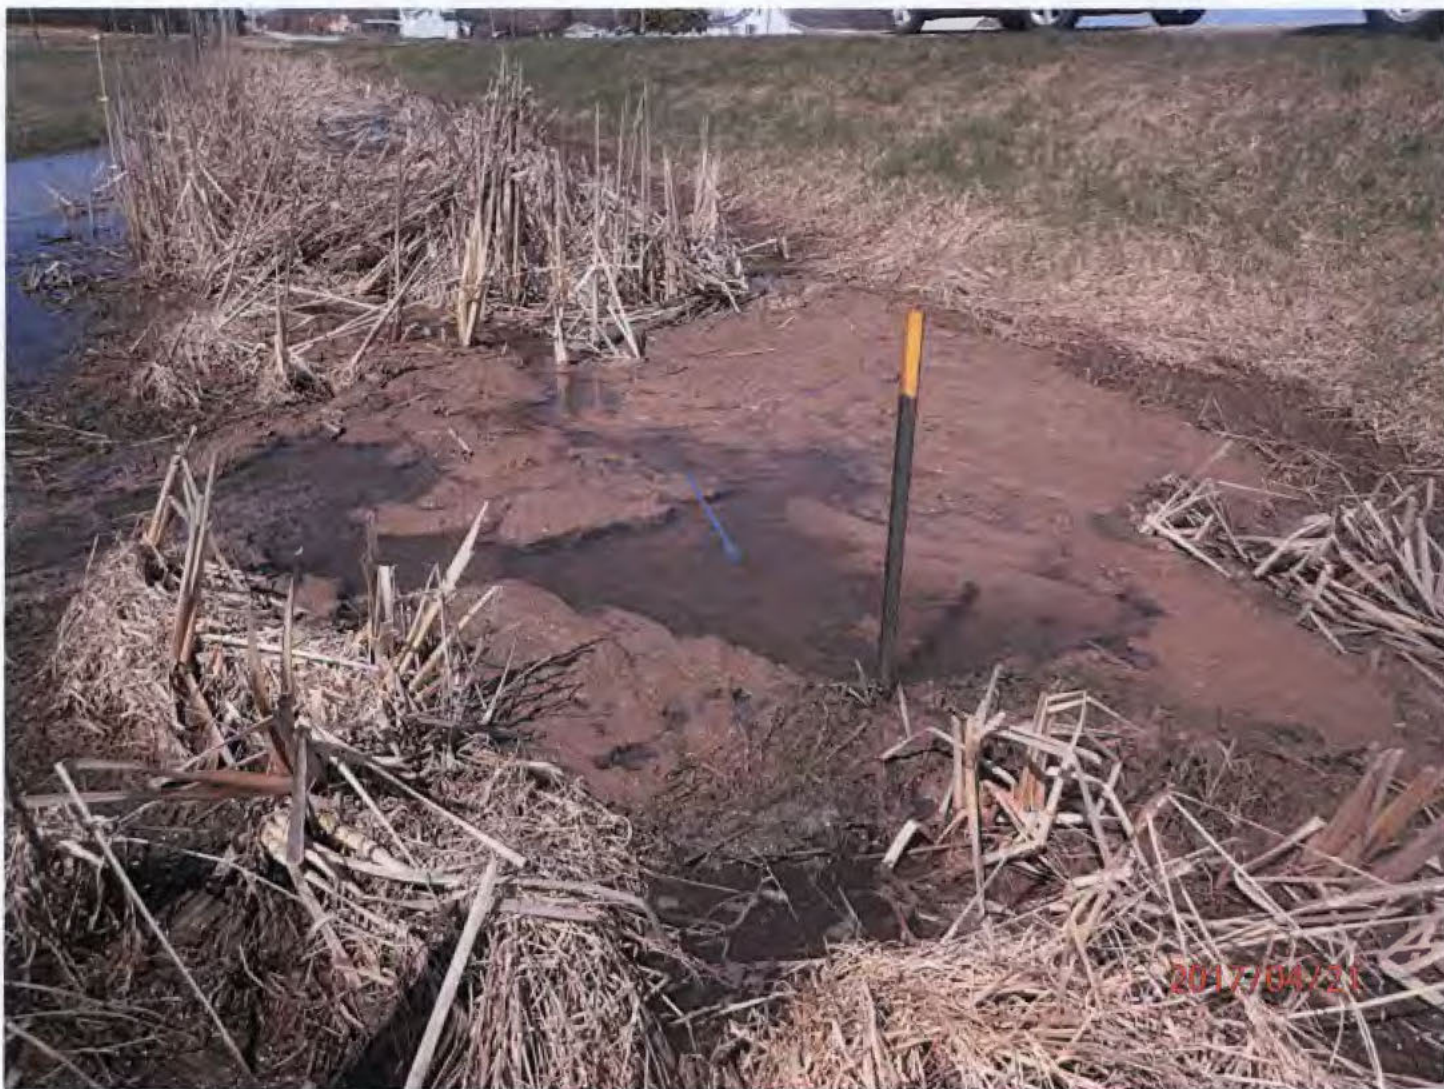
Photo: P4210071

Description: Blue arrow in photograph shows the ripples where WDNR identified the location of the tile outlet near the rebar.

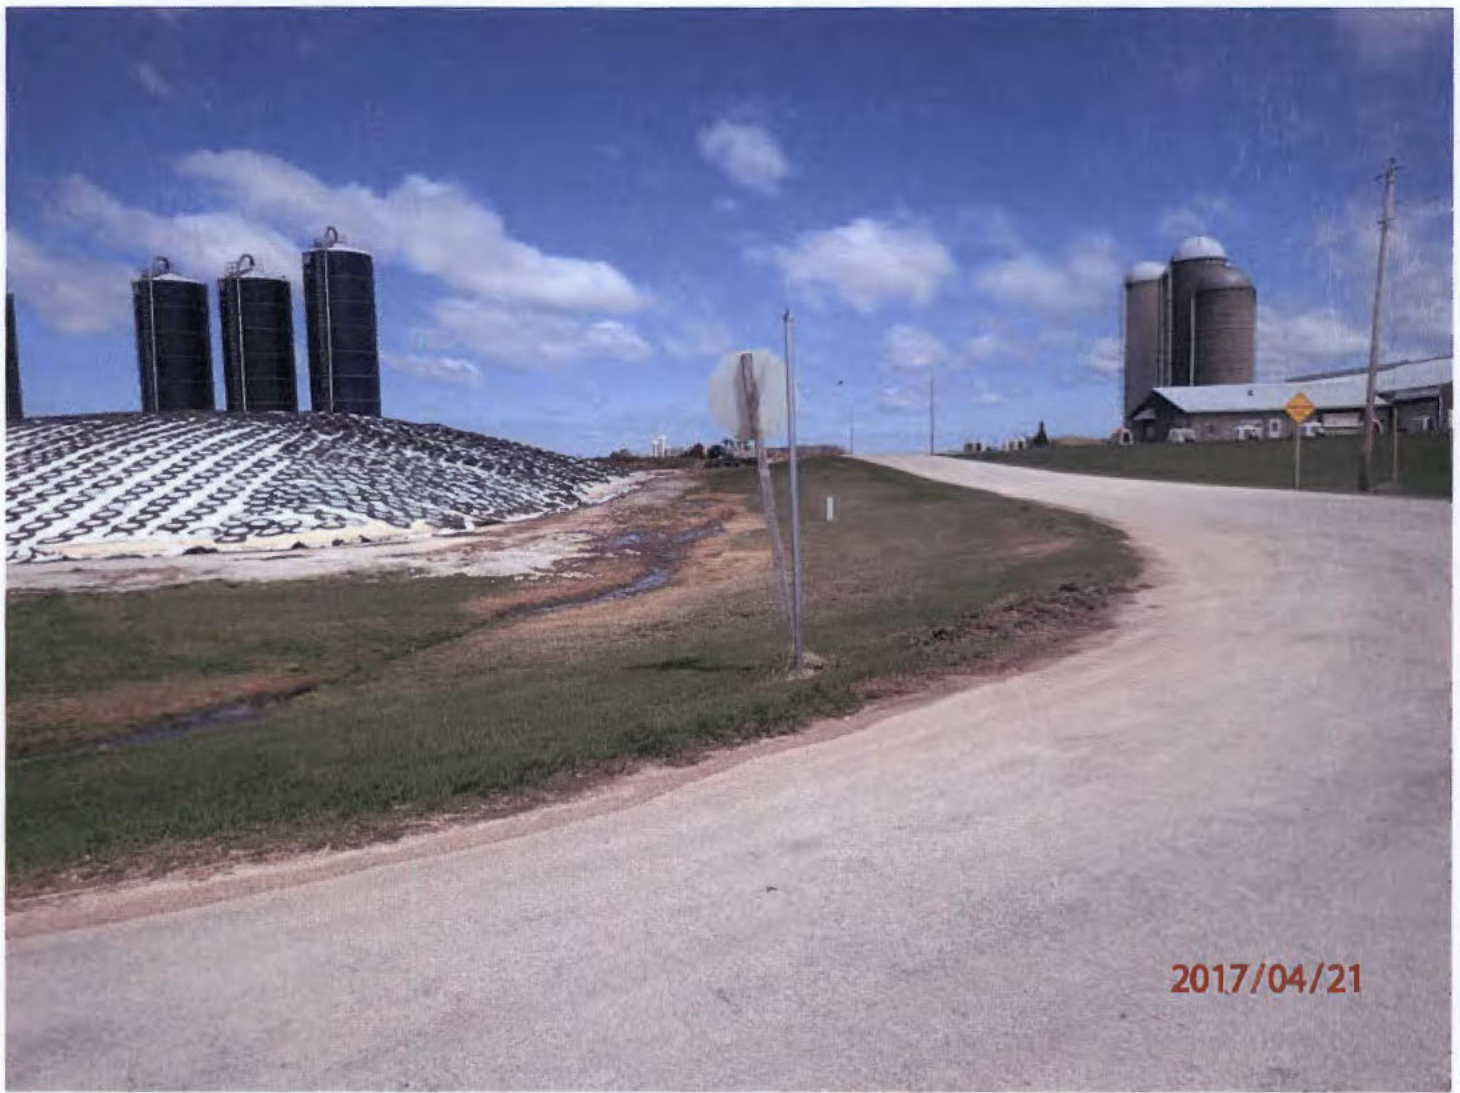
Photo: P4210072

Description: EPA observed process wastewater discharging off of the east side of the silage pad into the roadside ditch west of Lilac Lane. The process wastewater flows south into the roadside ditch north of County Road F.

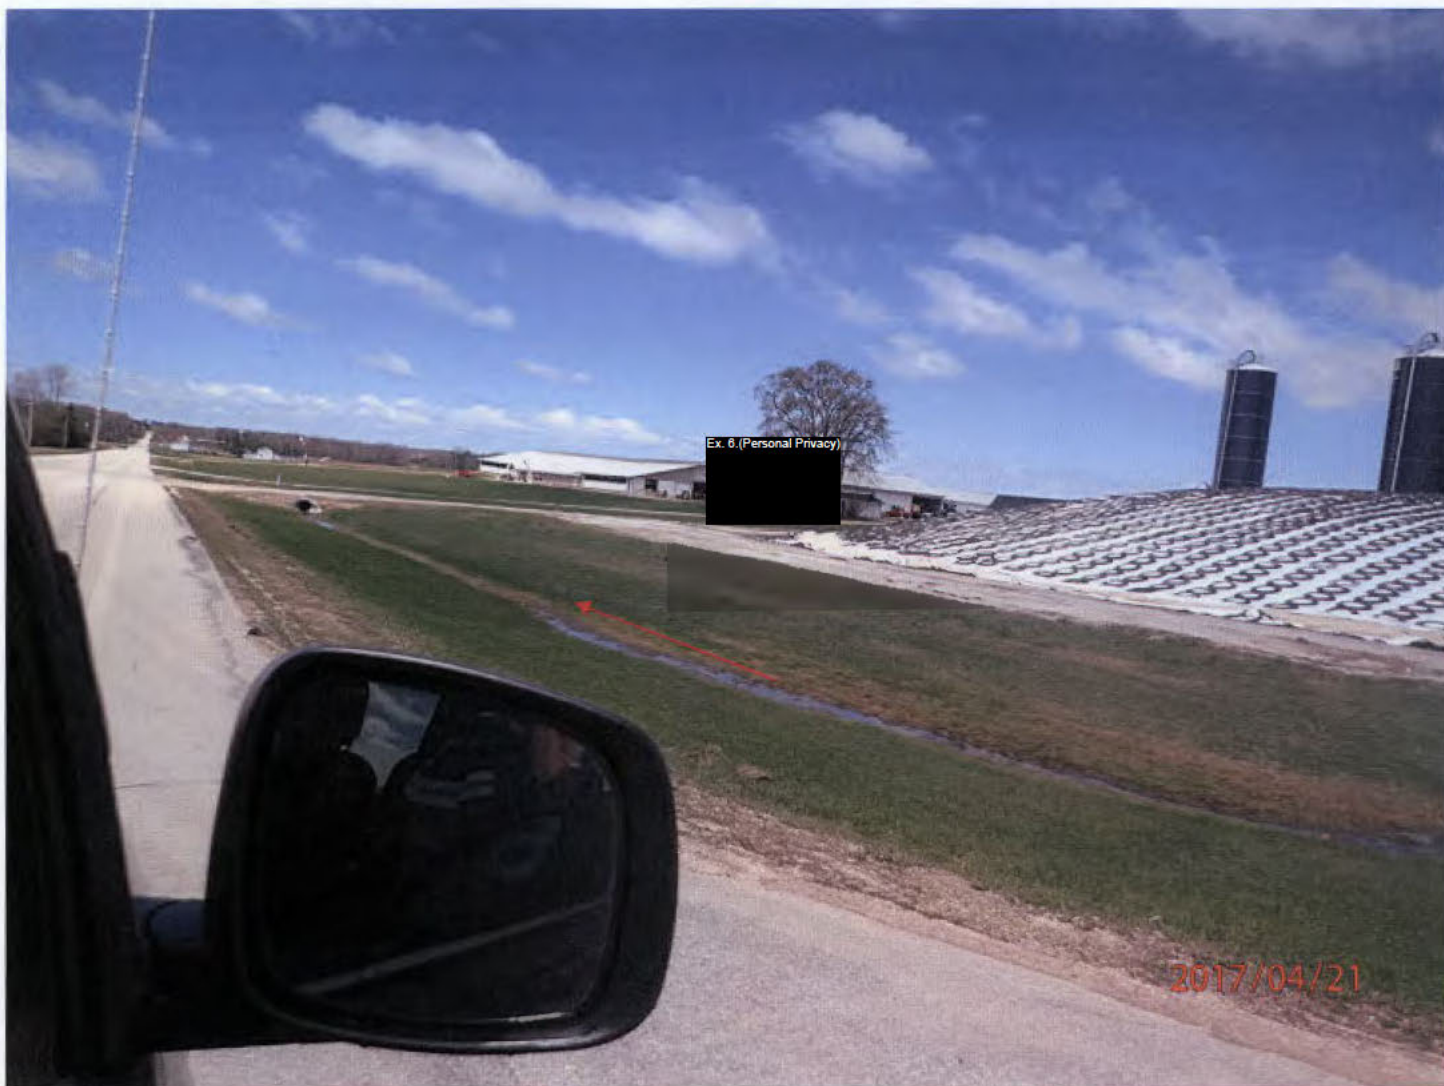
Photo: P4210073

Description: EPA observed the process wastewater flowing west in the roadside ditch north of County Road F toward the culvert that runs under the 1st driveway west of Lilac Lane.

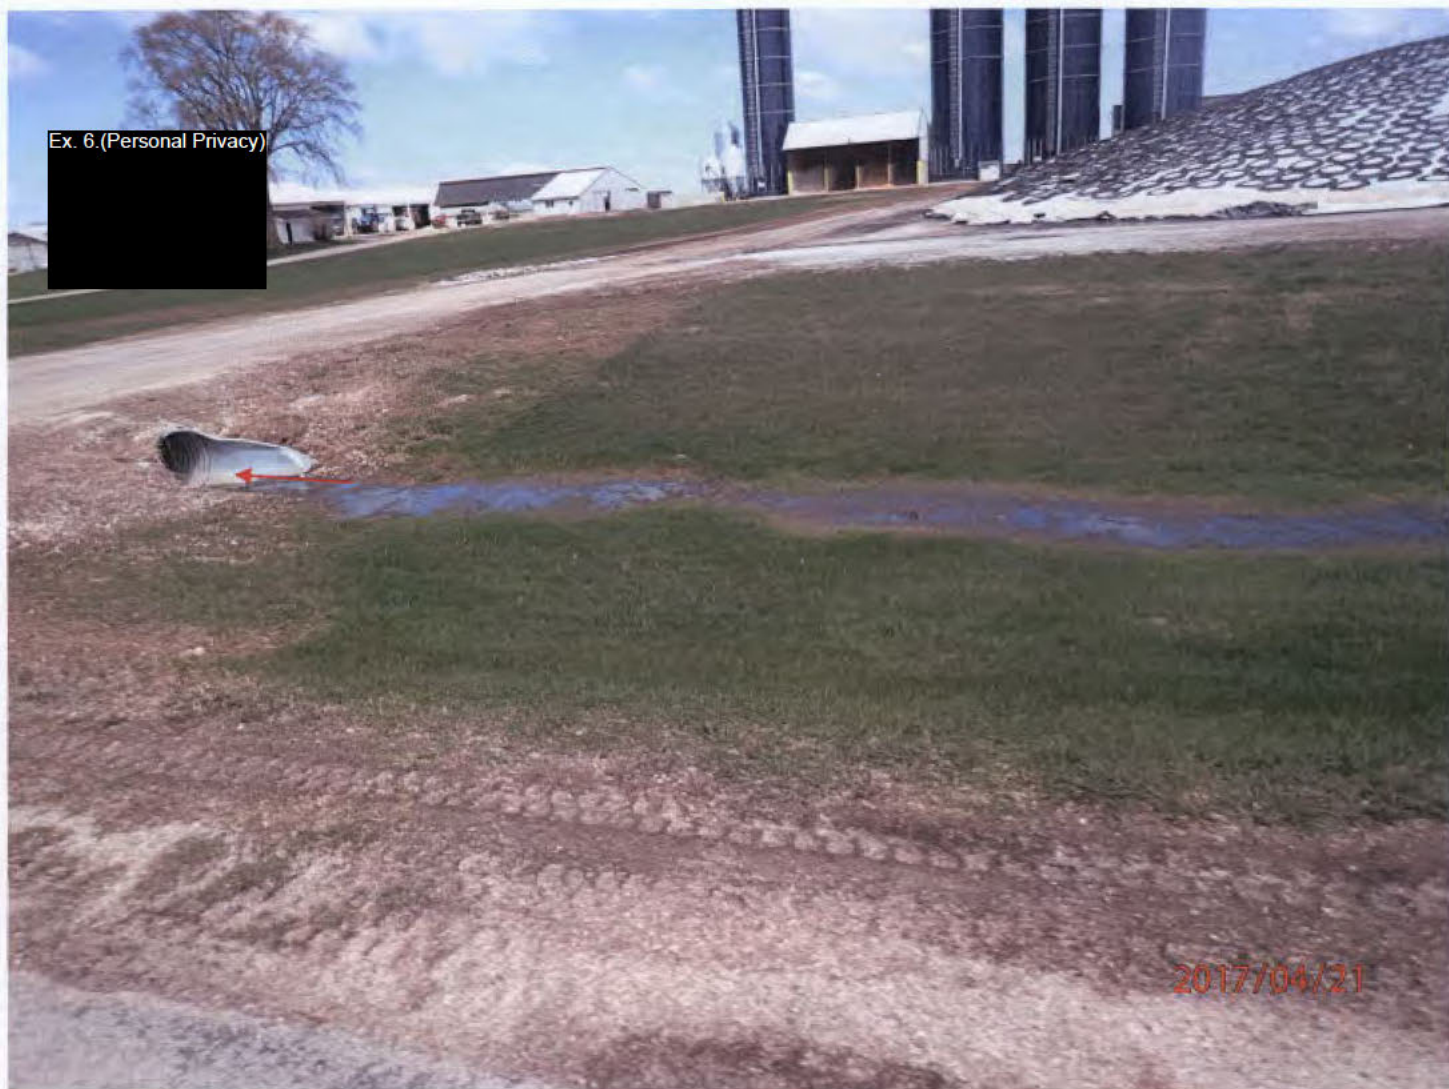
Photo: P4210074

Description: EPA observed process wastewater flowing west in the roadside ditch north of County Road F through the culvert under the 1st driveway west of Lilac Lane. Arrow depicts direction of flow.

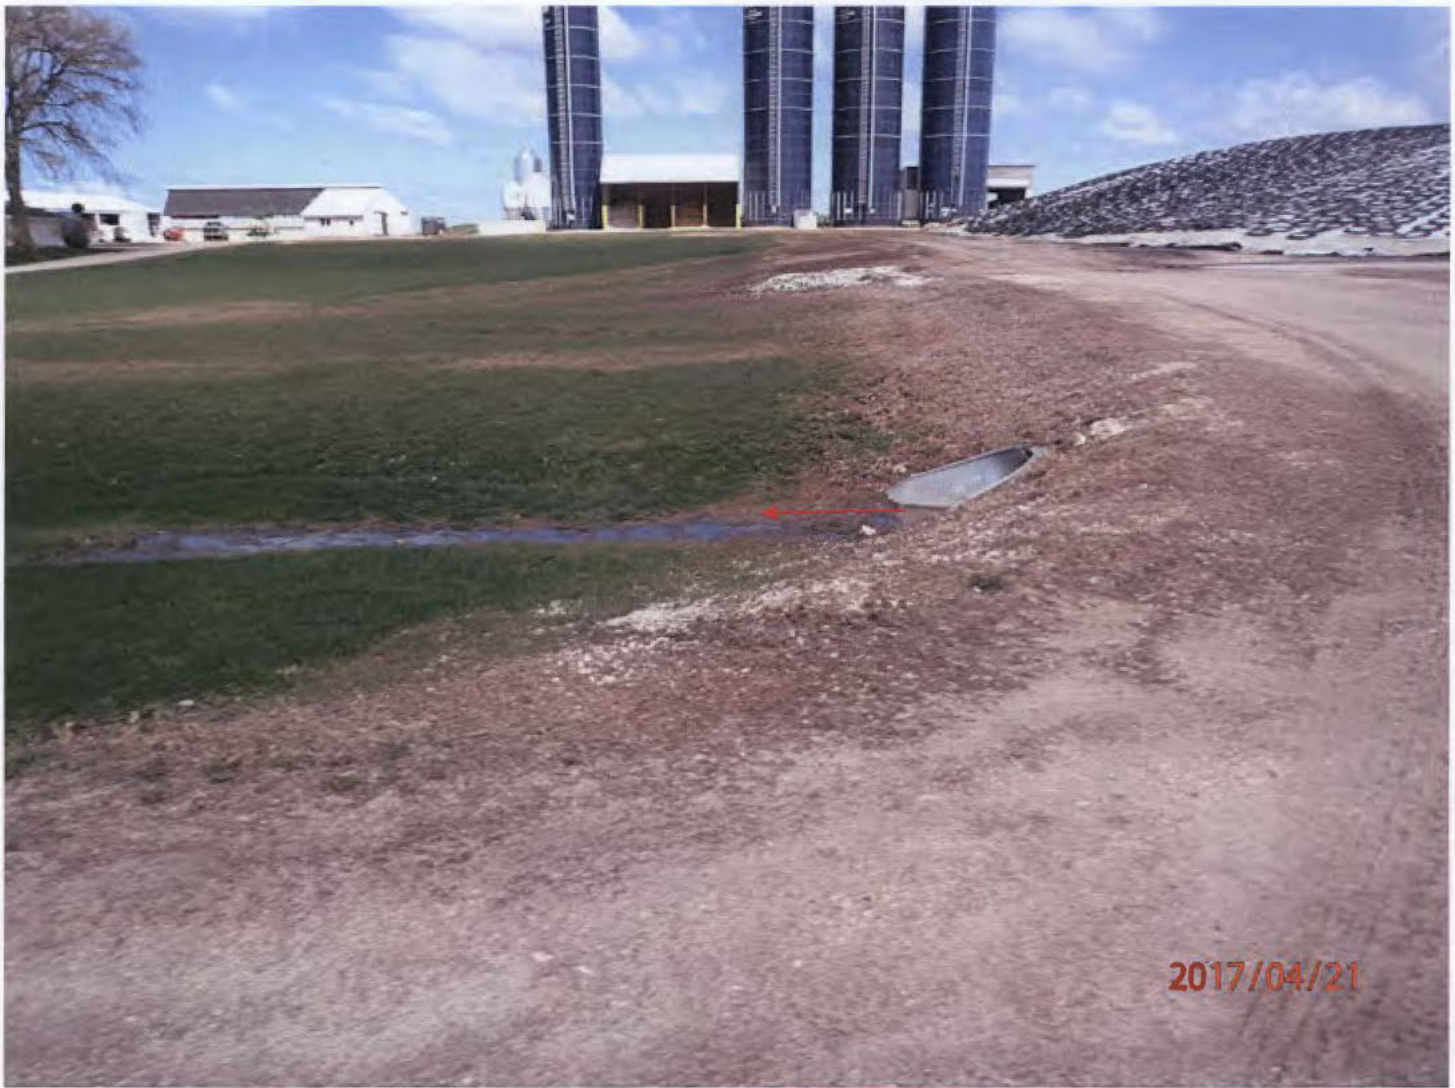
Photo: P4210075

Description: EPA observed process wastewater flowing west through the culvert outlet on west side of the 1st driveway west of Lilac Lane. The red arrow depicts the direction of flow.

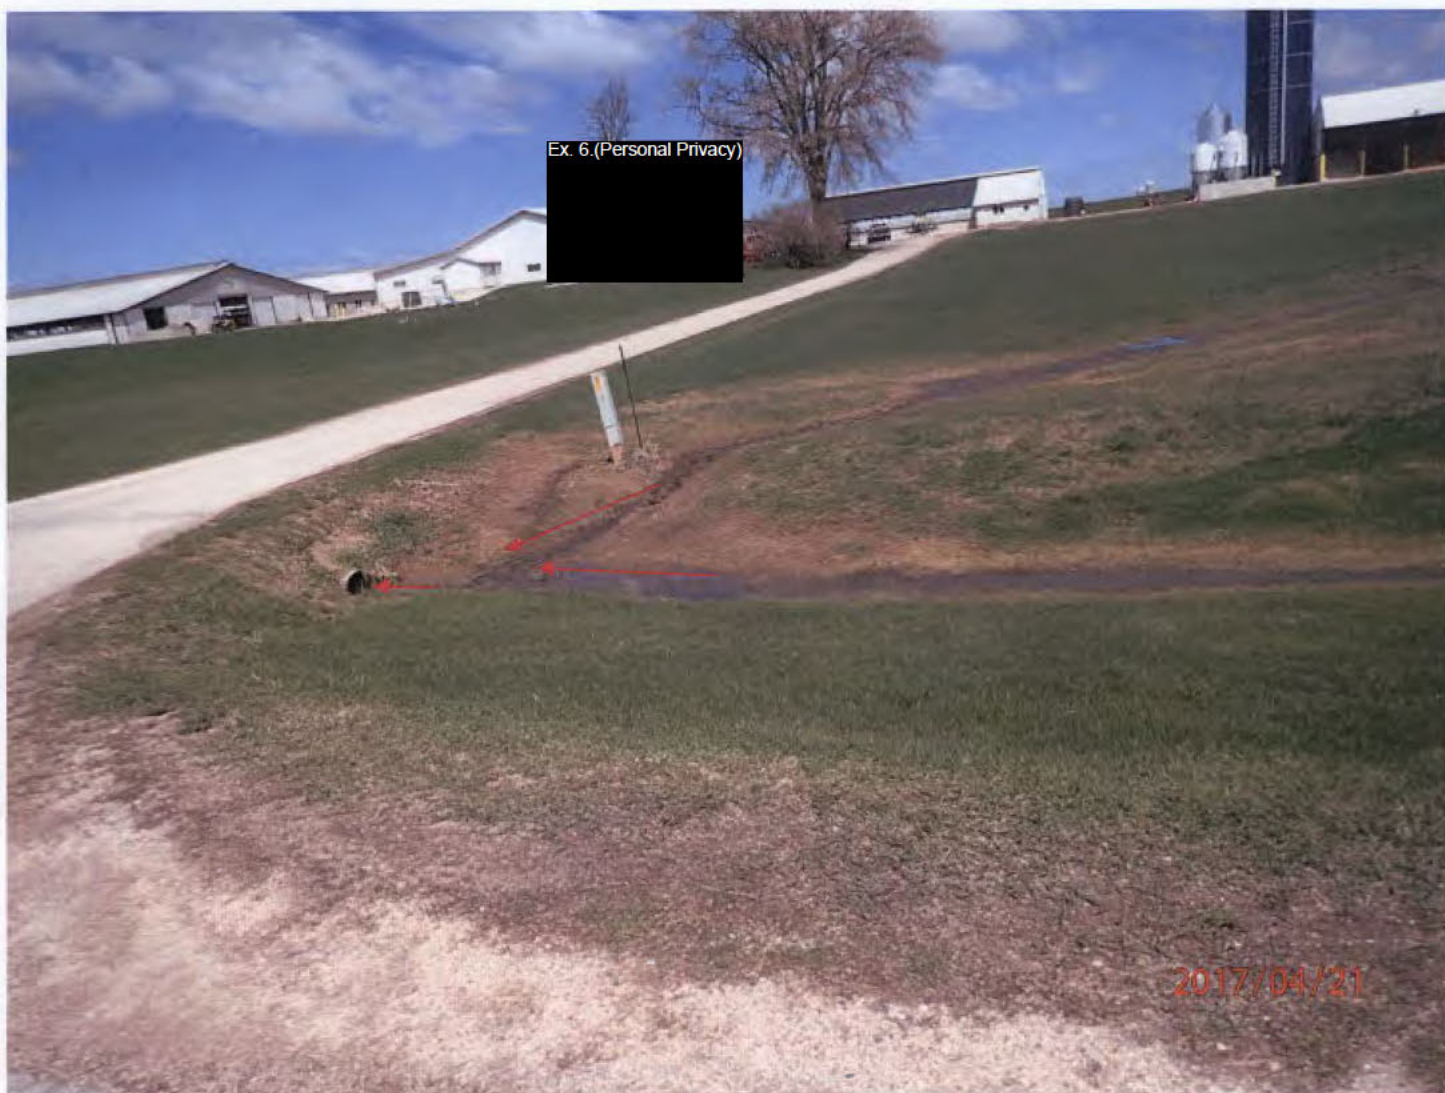
Photo: P4210076

Description: EPA observed the flow of process wastewater off of the west side of the silage pad and the process wastewater flowing west in the roadside ditch north of County Road F converge and flow through the culvert that runs under 2nd driveway west of Lilac Lane. Arrows depict the direction of flow from both process wastewater pathways as they converge and flow through the culvert.

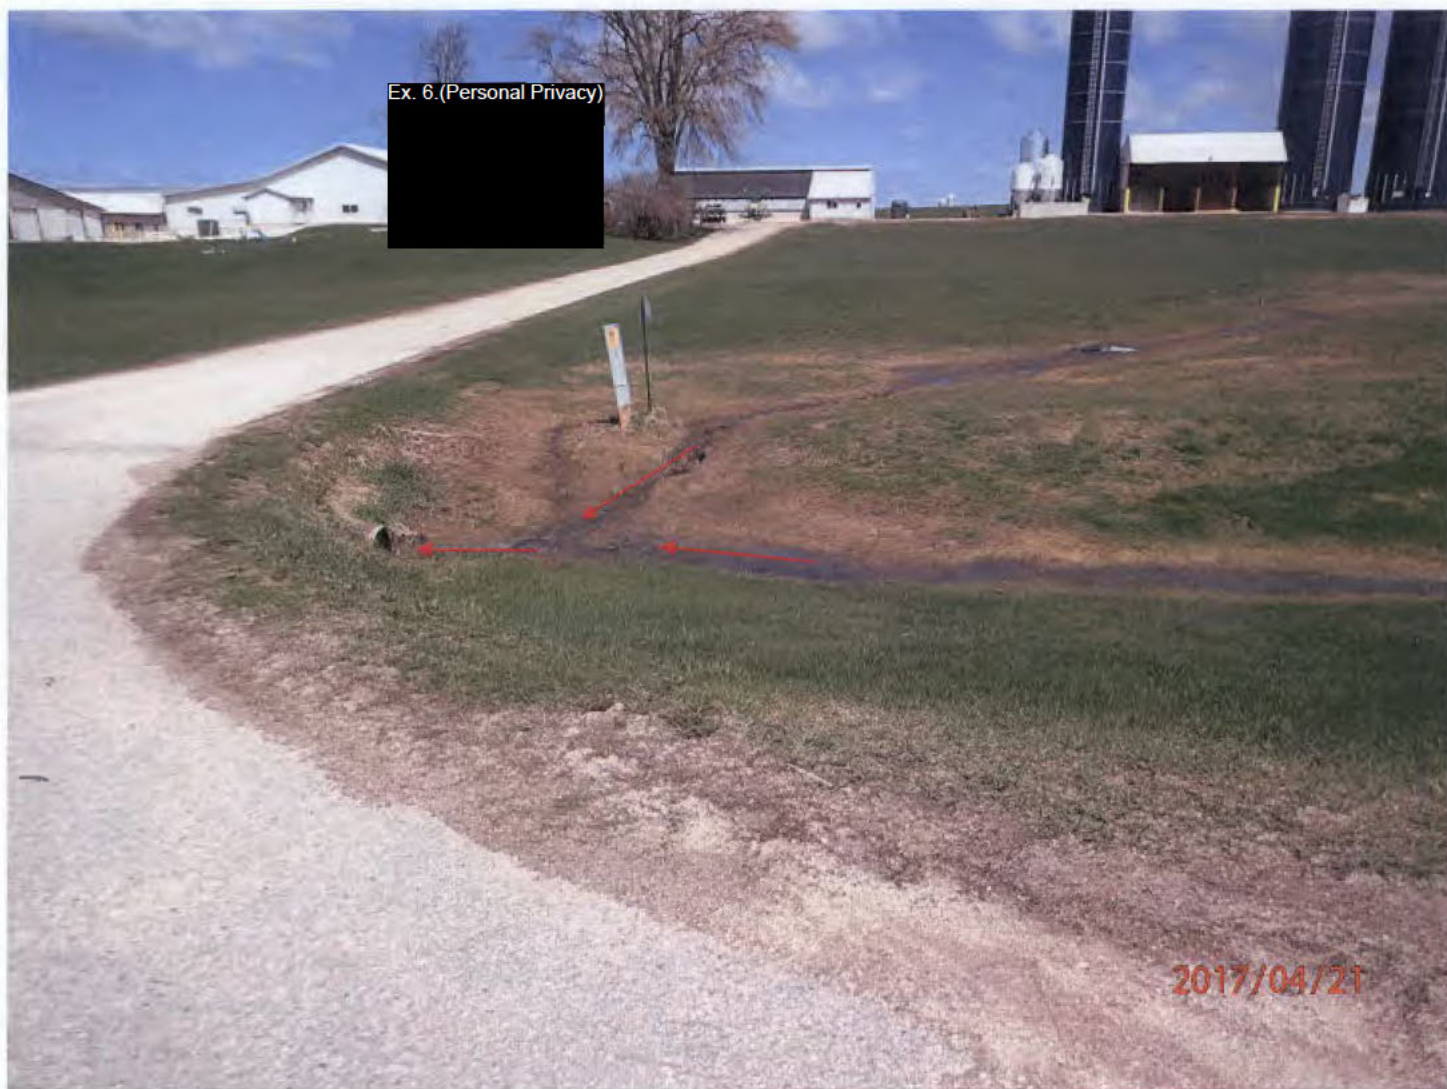
Photo: P4210077

Description: EPA observed the flow of the process wastewater off of west side of the silage pad and in the roadside ditch north of County Road F converge and flow through the culvert under 2nd driveway west of Lilac Lane. Arrows depict the direction of flow for both of the process wastewater pathways and show as they converge and flow through the culvert.
